THE REMR 19960621 001 BULLETIN

May 1996

Seismic Strengthening of Hotel Oakland Revisited: A Case Study

by Edward F. O'Neil, U.S. Army Engineer Waterways Experiment Station

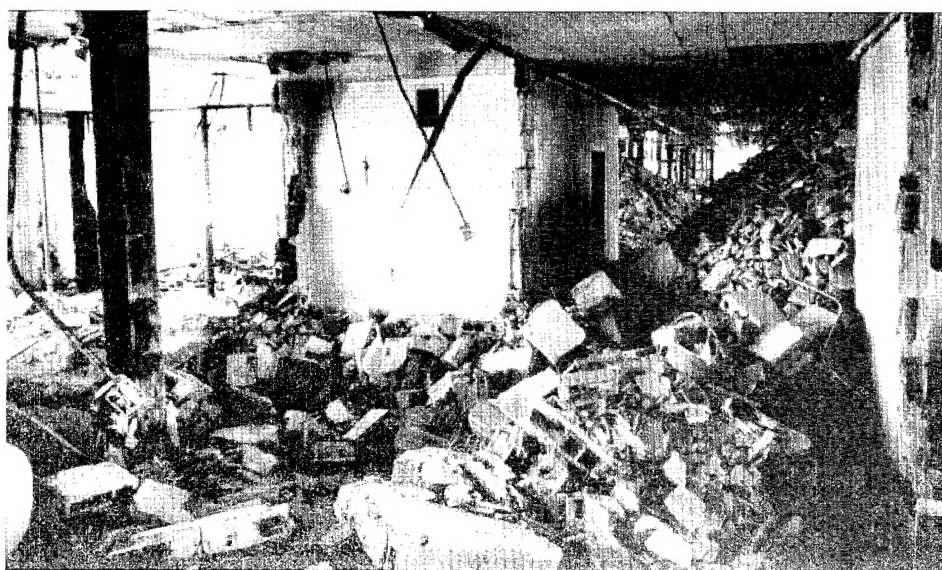
Figure 2. Clay tile partition rubble from 1979 renovations

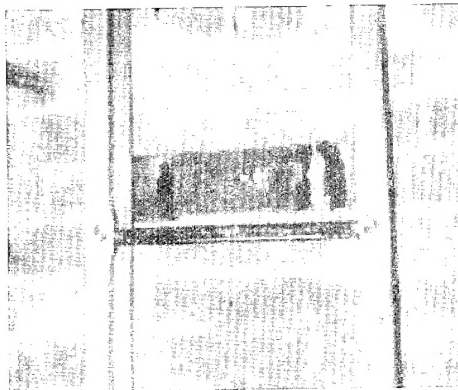
Figure 3. Structural studs and wall anchor

The system devised was incorporated into the new wall furring that was applied within the steel frames of the exterior walls (Figures 3 and 4). Heavier structural studs were mixed in with the basic stud-furring system and were spaced so that wall anchors could be secured on approximately 3-ft centers in both vertical and horizontal directions. The wall anchors were 1/2-in.-diam bolts that were long enough to extend from the structural studs through the two interior wythes of the exterior wall and into the face brick. The bolts were inserted into the wall through holes drilled into the brick to a depth including partial penetration in the face brick. They were then anchored to the brick with polyester-resin epoxy cartridges.

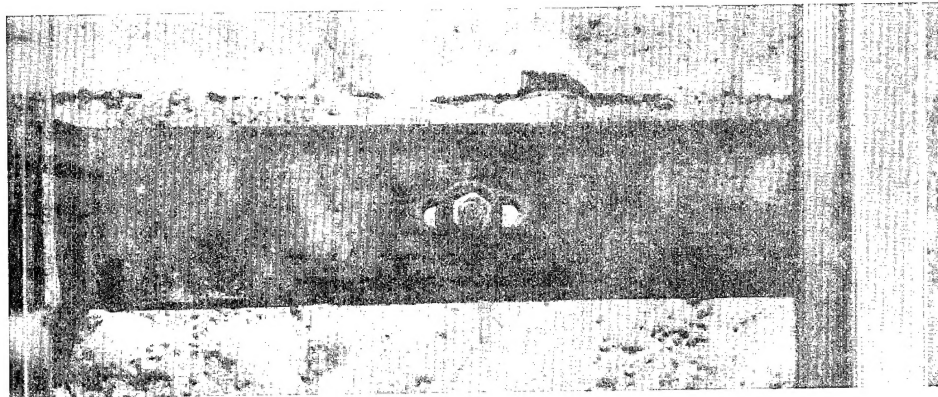
Figure 4. Detail of basketing anchor

To complete the wall anchorage, the bolts were attached to plates that spanned adjacent structural studs. The stud system then provided a positive anchorage detail to the floor framing above and below. Thus, the exterior wall system was reinforced with steel studs having the capacity to brace the walls against out-of-plane forces after failure of the brick. The system was intended to hold the brick in place, reduce potential falling hazard, and use the crushing of the brick during an earthquake for its energy-absorbing value.

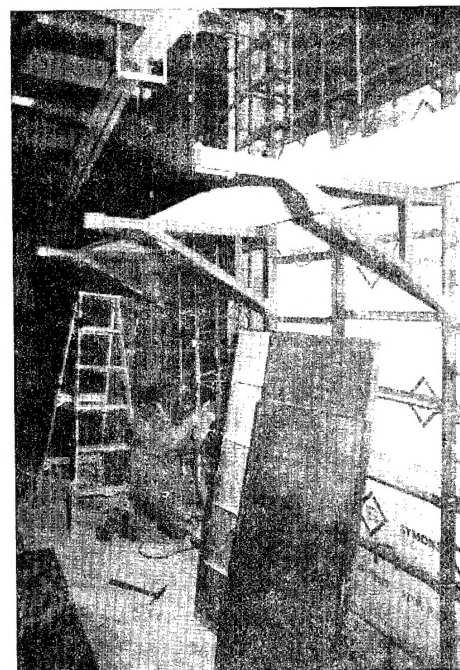
Figure 5. Forming for interior shear walls

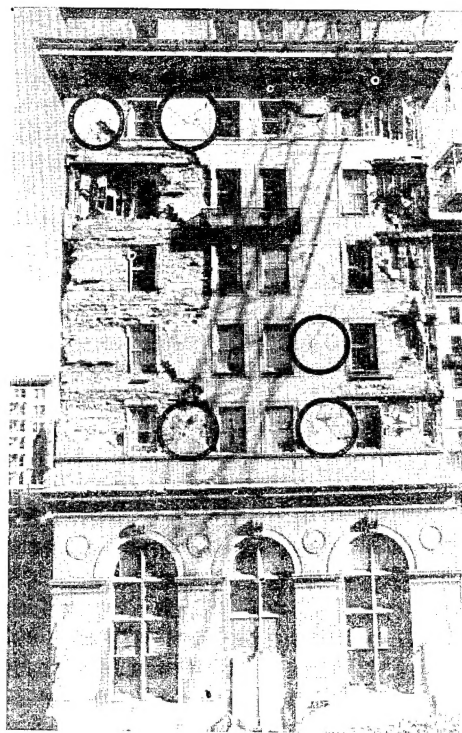
The most significant damage sustained by the hotel was cracking of some of the exterior brick walls. Although not load-bearing, these brick walls were the stiffest elements in the building, and they resisted the main thrust of the earthquake force. The damage was manifested as diagonal (X) cracks in the wall piers with virtually no cracking in the horizontal spandrels (Figure 6).

In the most severely damaged wing, the cracks were over 1/2 in. wide, with complex fracturing through the entire thickness of this wall. There were also areas where the face brick had fallen and other areas where it was loose. The damage in this area was enough to create a potential life-safety hazard that could not be ignored. An aftershock could dislodge portions of the wall that could fall on people below. It appeared that the brick in this area would have to be removed and replaced.

Figure 6. Damage to southwest facade after removal of loose brick

The exterior brick walls required significant work to repair the cracks caused by the earthquake. The cracks were injected with epoxy to restore original strength, and the finish was then patched to match the adjacent surfaces as closely as possible. The restoration process was complicated by the effects of cleaning on the existing material and on the new face brick and mortar.

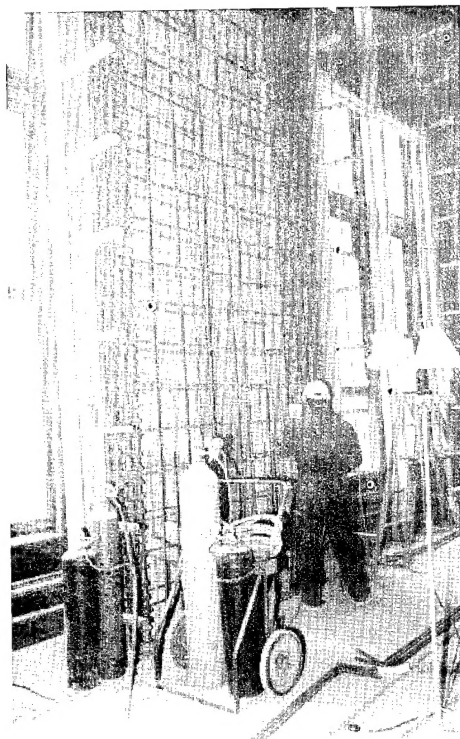
Figure 7. Strengthening of walls behind historical facades

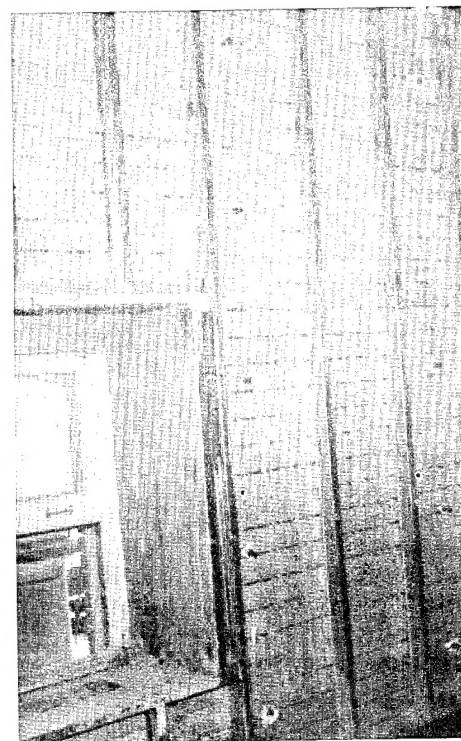
Figure 8. Strengthening of typical upper floor walls
